DAILY REPORT

PROJECT	San Jacinto River Waste Pits TCRA	CONTRACT NO.	
CONTRACTOR	USA Environment, LP	SUPERINTENDENT	Ron Griffith
DAY OF WEEK & DATE:	Thursday, May 12, 2011	REPORT NO.	101
WEATHER	Mostly cloudy, moderate-to-strong wind from south	TEMPERATURE	L:70° H:85°F
<u>NUMBER/CLASS OF CONTRACTOR'S PERSONNEL:</u>		<u>MAJOR EQUIPMENT ON JOB (Size/capacity):</u>	
11 – USA Environment (USA) 11 – Shirley & Sons		LaBarge Property Komatsu PC300LC Excavator (2) Komatsu PC200LC Excavator Komatsu D61 Dozer Deere 624J Front-end Loader Deere 644J Front-end Loader Crane Work boat with winch TxDOT ROW/SJRWP Cat Long Reach Excavator JCB Long Reach Excavator Cat 930 Loader Cat D5 Dozer Water Truck Barge-Mounted Excavator (2) 'Jim Dandy' Tug Boat Jon Boat Aggregate Transport Barge	
<u>TIDE INFORMATION:</u>		<u>HEALTH AND SAFETY INFORMATION:</u>	
Time: 09:00	Location: SG-03	Height (inches): 25	No incidents or near misses on this date.

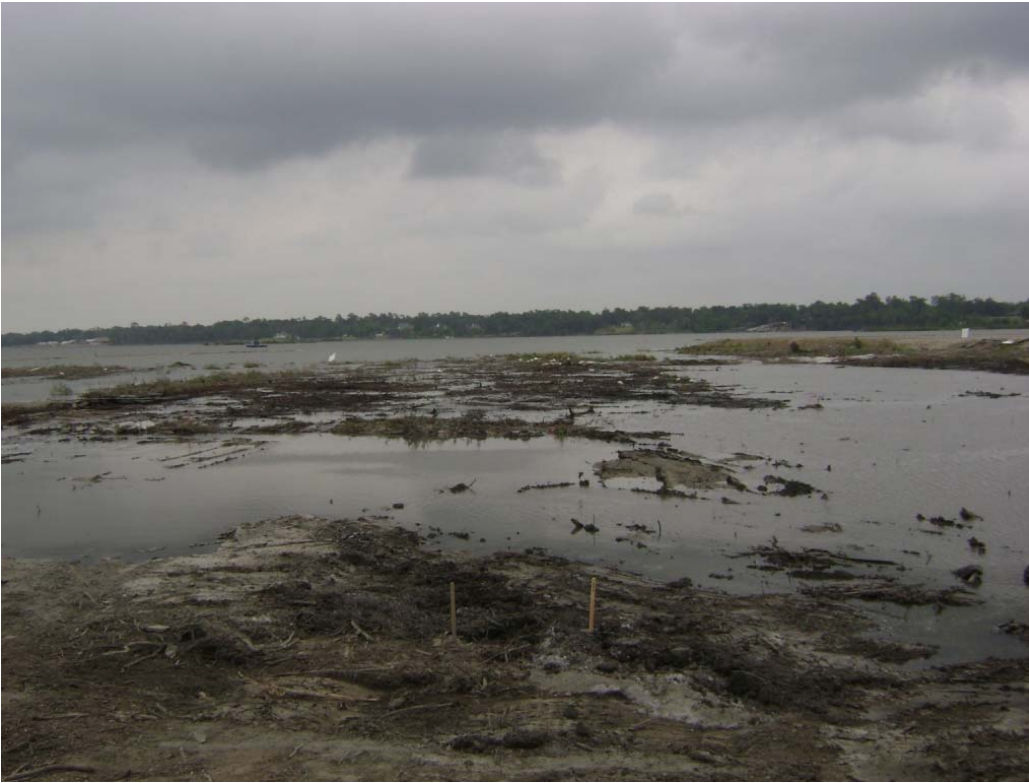
Photo 1 – Western Cell during elevated tide level on the afternoon of Wednesday, May 11, 2011.

Note: Cement delivery for stabilization of the Western Cell has been postponed for today due to high water levels in the Western Cell

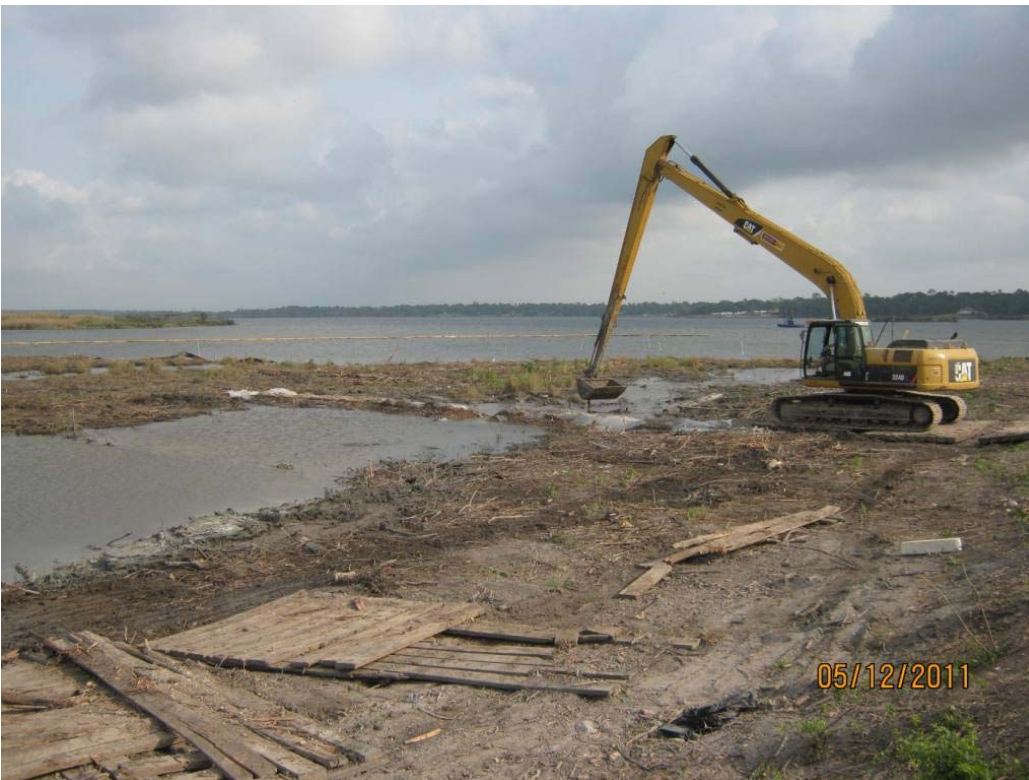
Photo 2 – Breaking an opening into the interim berm to allow the tide to recede in the Western Cell.

- Placing Armor Cap C rock in the Eastern Cell (water-based operations)
- Releasing tide water from the Western Cell by breaking an opening into the interim berms
- Picking up trash and debris around the TxDOT ROW/SJRWP area

- Broke open interim berms to release tide water from the Western Cell
- Picked up trash and debris around the TxDOT ROW/SJRWP area
- Placed Armor Cap C rock in the Eastern Cell (water-based operations)

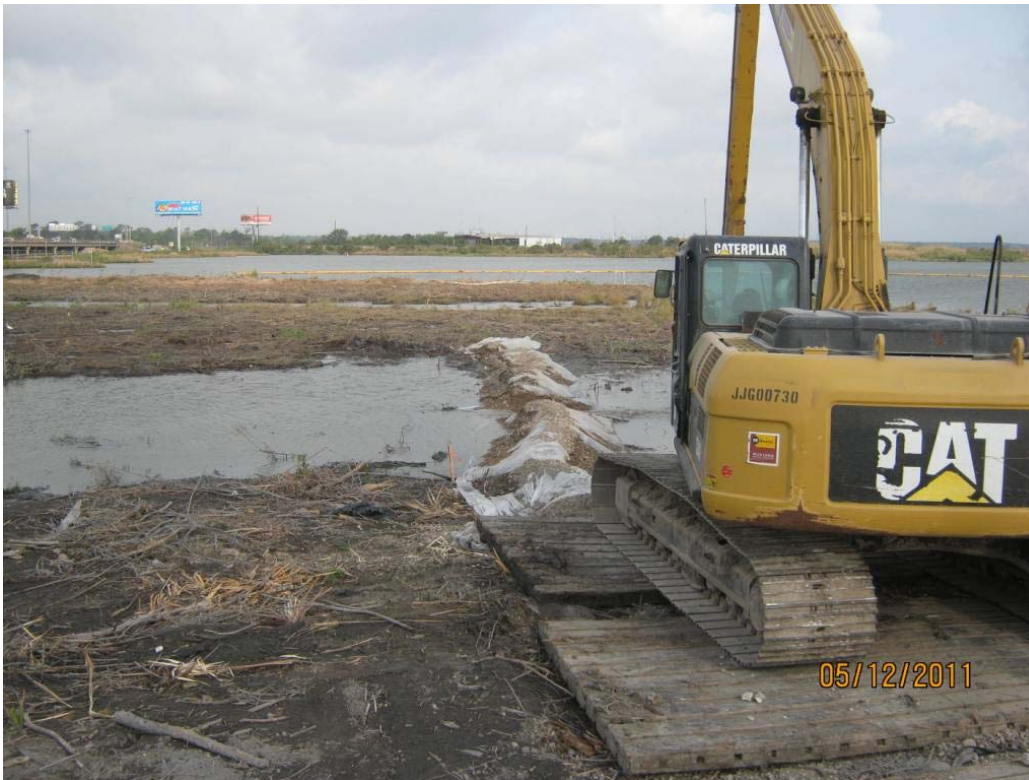
Photo 3 – Breaking an opening into the interim berm to allow the tide to recede in the Western Cell.

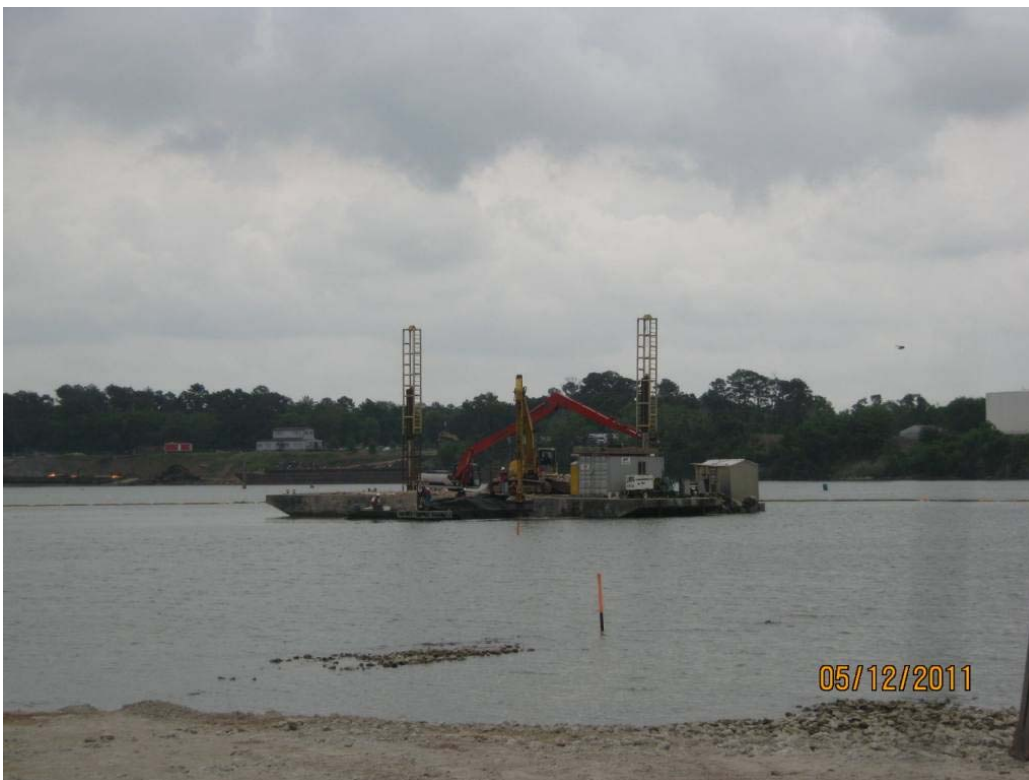
Photo 4 – Placing geotextile and Armor Cap C rock in the Eastern Cell.

- 13:40 Geotextile deployment and Armor Cap C placement (third load of the day) began in the Eastern Cell.
- 13:50 R. Brown and the Texas Department of Health (three persons) mobilized to the Admin area.
